TECHNICAL NOTE

No. 1095

MARINE EXPOSURE TESTS ON STAINLESS STEEL SHEET

By Willard Mutchler

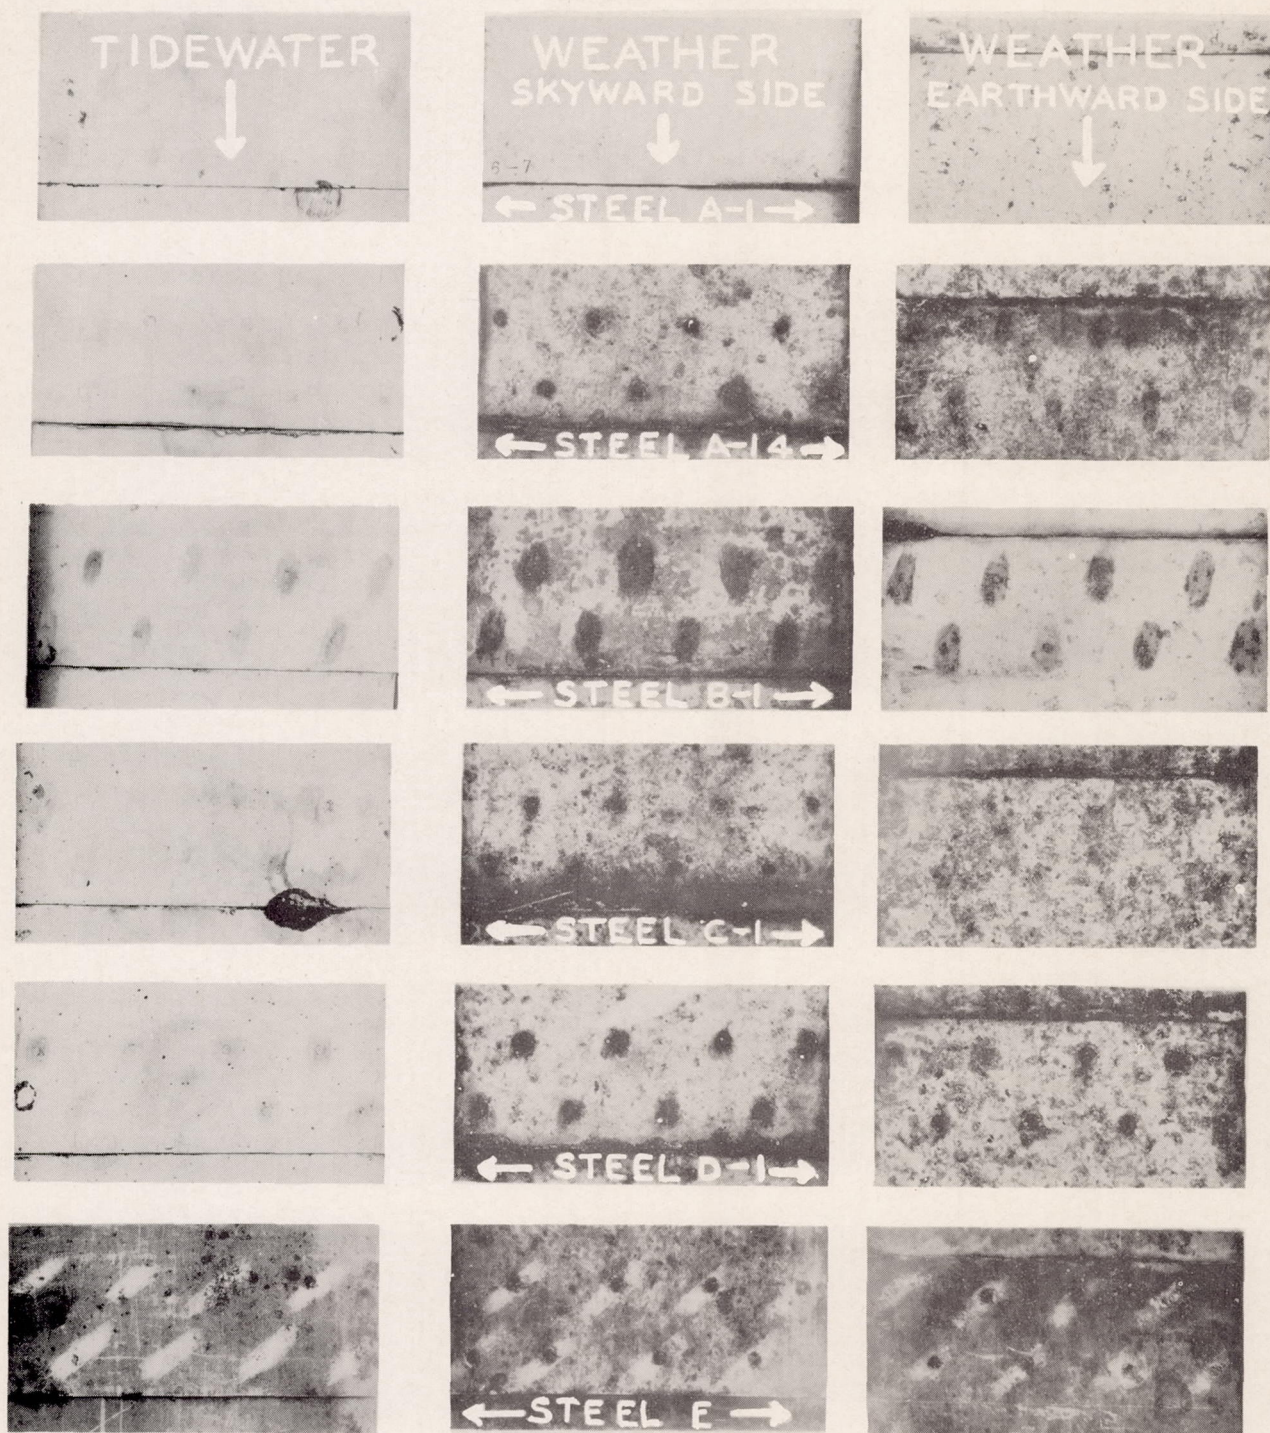
The panels exposed to the tidewater for 3 years (fig. 8) exhibited only a very few areas of rust, most of which occurred adjacent to the overlapped edges on the shot-welded panels. Examination of the surfaces at low magnifications revealed widely scattered, shallow, "pin-point" pits, around which rust was rarely visible. The wide discrepancy of results of the visual examinations, made by a number of different observers, indicated that it was virtually impossible to rate these steels by that method according to their relative susceptibility to corrosion. Steel E, however, exhibited numerous 'pin points' to approximately 1/8-inch diameter areas of superficial rust, which occurred during the first 6 months of exposure, and were not much worse after 36 months of exposure. It therefore, was consistently rated inferior in its corrosion resistance to steels of the 18:8 type.

At intervals of 6 months or less the rust was cleaned from some of the panels (steel A1, fig. 8) with a commercial cleaner. This is a paste-type cleaner containing a grit, which leaves a water repellant wax film on the metal after polishing. Minute pits were observable under most of the rusted areas after this cleaning. Such periodic cleaning did not prevent corrosion, but appreciably retarded the rate at which rust formed. A panel, for example, cleaned after 30 months of exposure showed less rust at the end of the 36th month (fig. 8), than a similar panel, not cleaned, after its initial 6 months of exposure.

Figure 8.- Stainless steel panels, of various chemical compositions, exposed to the tidewater or weather at Hampton Roads, Va. for 36 months. Note that Steel B-1, containing 3.7 percent of molybdenum exhibited the least rust especially on the earthward surface, while Steel E, of the 16:1 type, showed the most rust. Steel A-1 was cleaned periodically, the others were not. x 1/2.

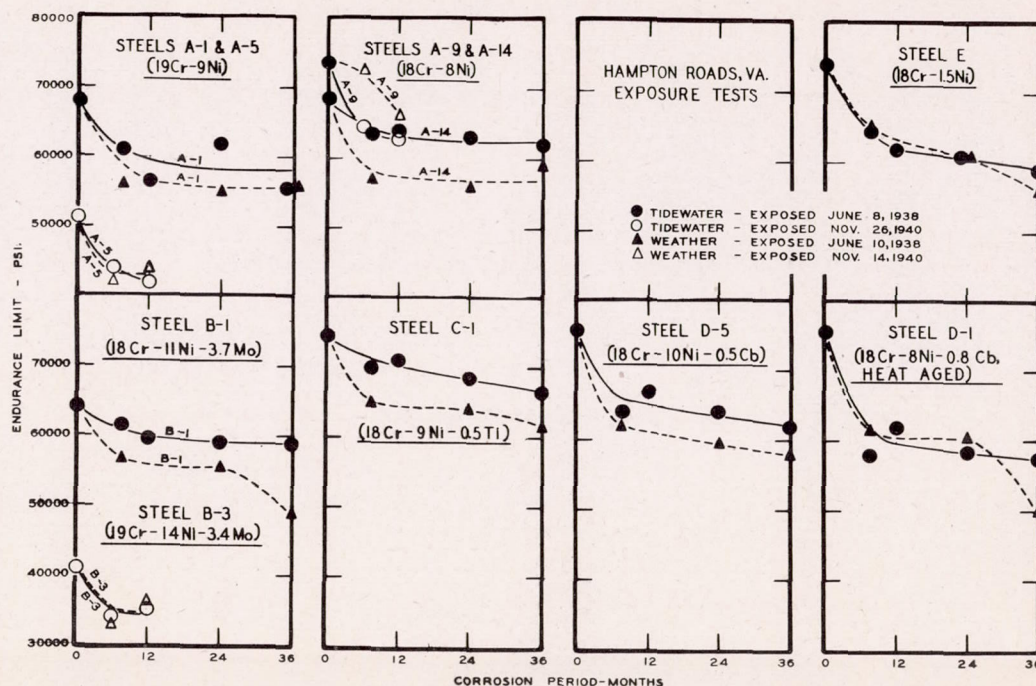
Figure 16.- The charts summarize the data for each of the steels (figs. 9-15, 19-21) exposed at Hampton Roads, Va., and show the loss in fatigue limits as related to the period of exposure. Panels exposed in 1938 were located at Boush Creek, while those exposed in 1940 were located at the Lagoon.

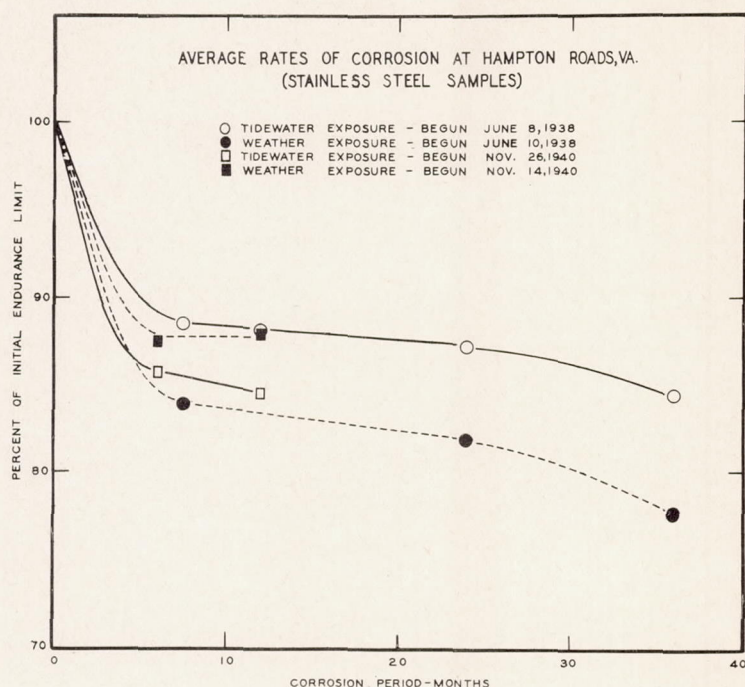
6. The relative susceptibility to corrosion of the particular sheets under the specific conditions of exposure used in these investigations (fig. 17) could be established by fatigue tests. These revealed a superiority in the steels containing molybdenum or titanium, and an inferiority of the heat-aged columbium-bearing steel and one of the 16:1 type. The relatively narrow range of the loss in fatigue limits ( $\pm 5$  percent) for all the steels except the last two, indicated that the order of susceptibility may be expected to show variations, within the ranges established, on different heats of metal exposed under the same, or other marine conditions.

Figure 17.- Panels exposed in 1938 were located at the Boush Creek site, while those exposed in 1940 were located at the Lagoon, at the U.S. Naval Air Station, Hampton Roads, Va. The data are the average for all the stainless steel panels, irrespective of their chemical compositions.

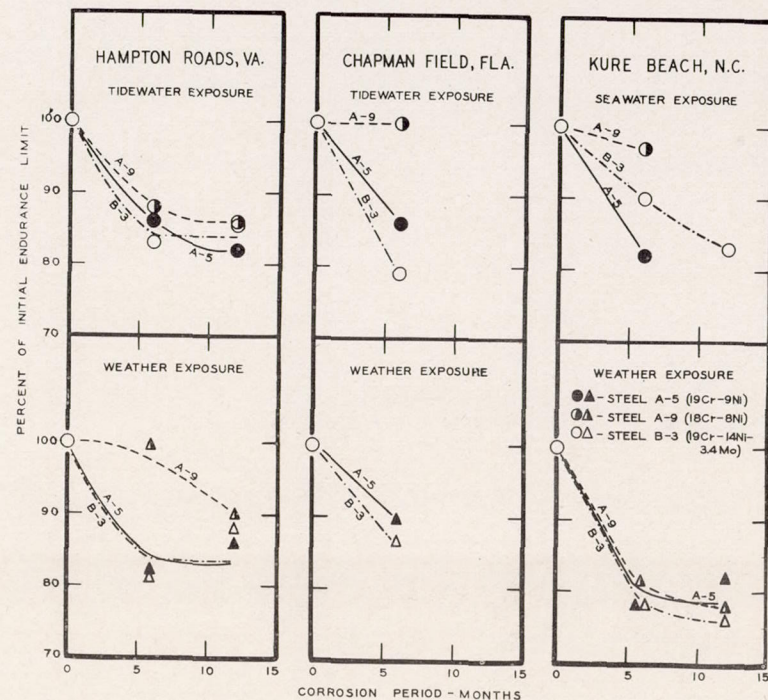
Two straight 18:8 type steels, one (A-9) with a tensile strength of 190,000 psi, and the other (A-5) with 100,000 psi, along with a 1/4-hard-rolled steel (B-3) having a tensile strength of 120,000 psi were exposed simultaneously at the three localities. The fatigue tests (fig. 22) revealed that steel A-9 usually was the least susceptible to corrosion. Steel A-5 was somewhat more resistant to corrosion than steel B-3 under all the conditions of exposure, except in the sea water at Kure Beach, N. C.

Figure 22.- The charts summarize the data for each of the steels exposed simultaneously at the three localities (figs. 19, 20 and 21), and show the loss in fatigue limits as related to the period and type of exposure.

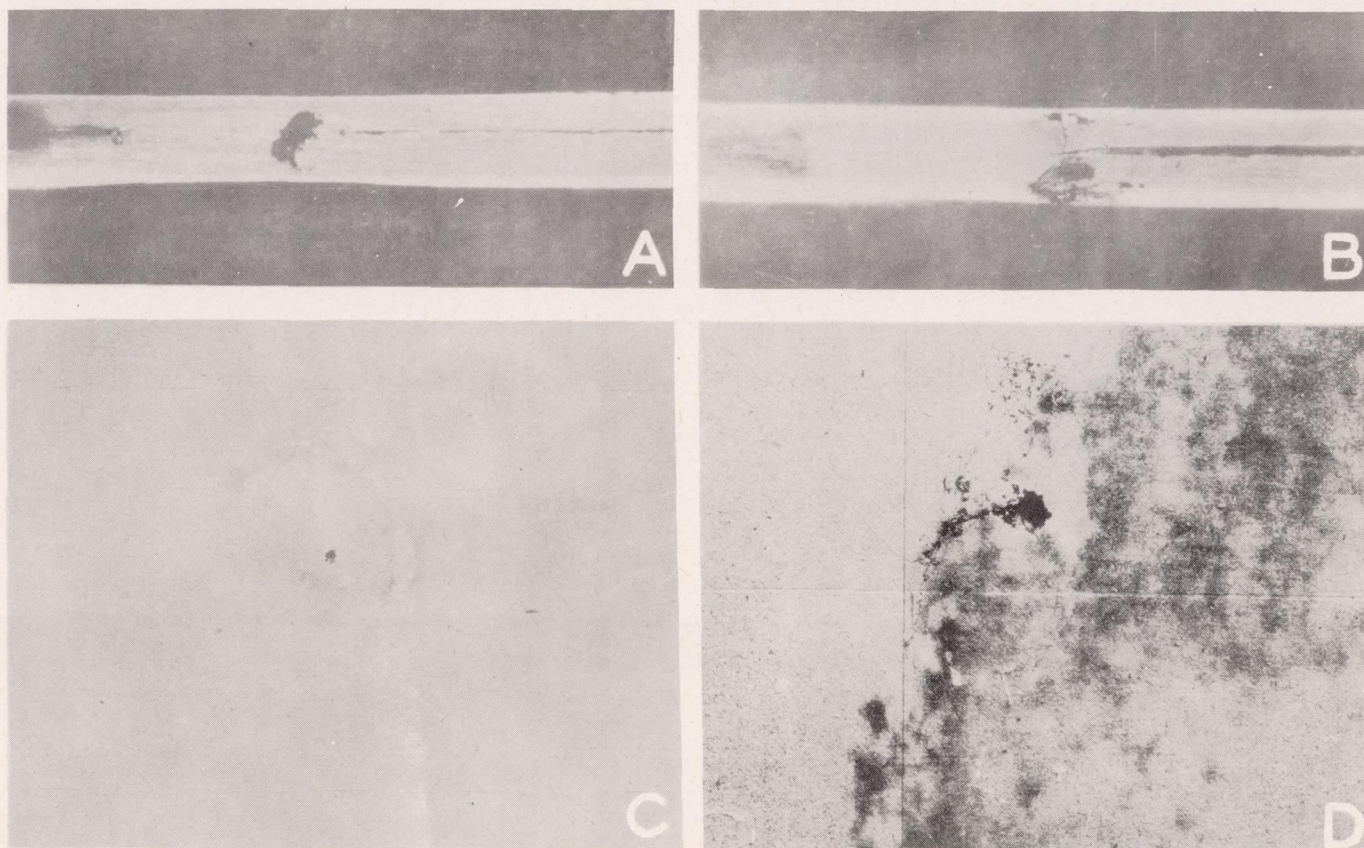
After 15 days of exposure in the boiling chloride solution exposed cross sections cut through some of the welds on steels C-1 and D-5 (figs. 23a and 23b) revealed severe corrosion. At the end of 120 days two of the welds in the titanium-bearing steel C-1, had failed (figs. 23c and 23d); while welds in the other samples contained only superficial pits.

Figure 23.- Corrosion on shot-welds exposed to a boiling solution of mixed chlorides in laboratory tests. A, Pits in Steel C-1 (titanium-bearing) on a welded cross-section exposed for 15 days. x 10; B, Steel D-5 (columbium-bearing), exposed under the same conditions as in "A". x 10; C, Pin-hole on Steel C-1 shot-weld, which developed in 100 days. x 9; D, Corrosion at the edge of a shot-weld on Steel C-1 after 120 days. x 9.

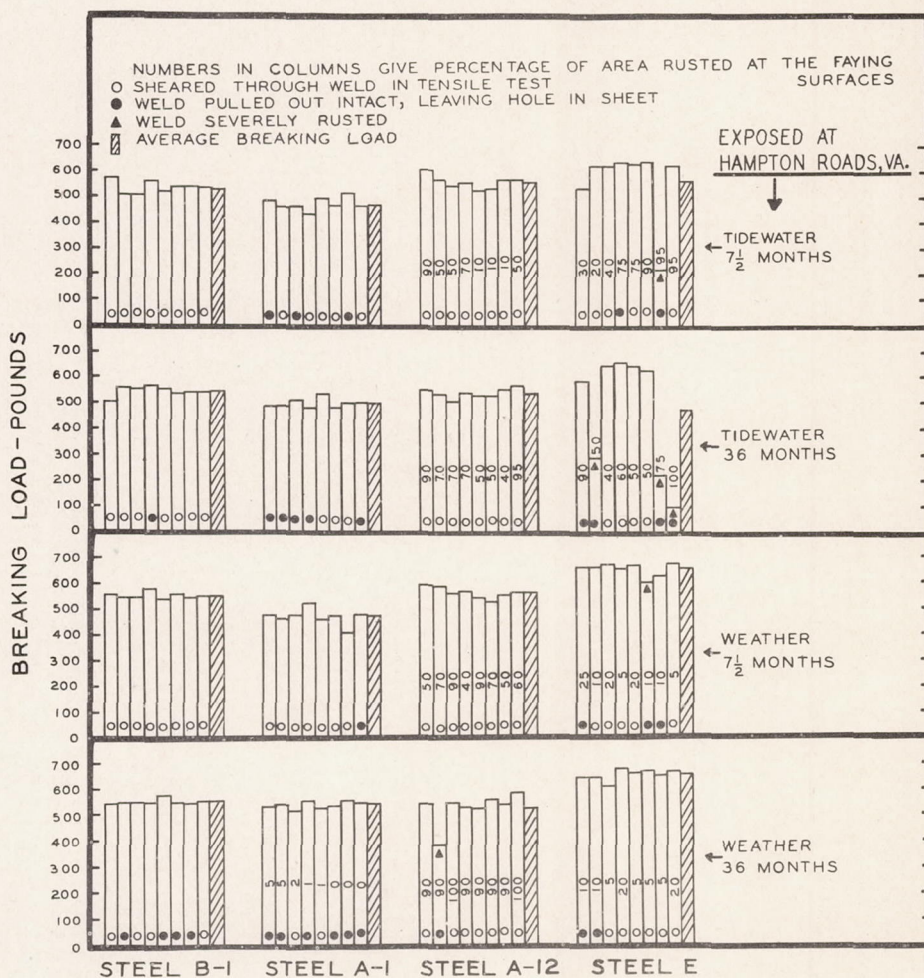
Representative results of the tensile tests on a few of the steels (fig. 24) reveal that, except for isolated instances on corroded welds, the range in breaking loads for the single welds was within narrow limits. The highest values were obtained on steel E. Tests made at the E. G. Budd Manufacturing Company on similar welds in this 16:1 type steel, showed that they would withstand a twist of only  $10^\circ$  before failure; whereas welds in the 18:8 type steels withstood a twist of  $90^\circ$  before failure. Shot welds in alloys corresponding to steel E probably would not prove as satisfactory as the austenitic type alloys for highly stressed structures.

Figure 24.- Results of tensile tests on individual shot-welds from representative panels after exposure at Hampton Roads, Va.

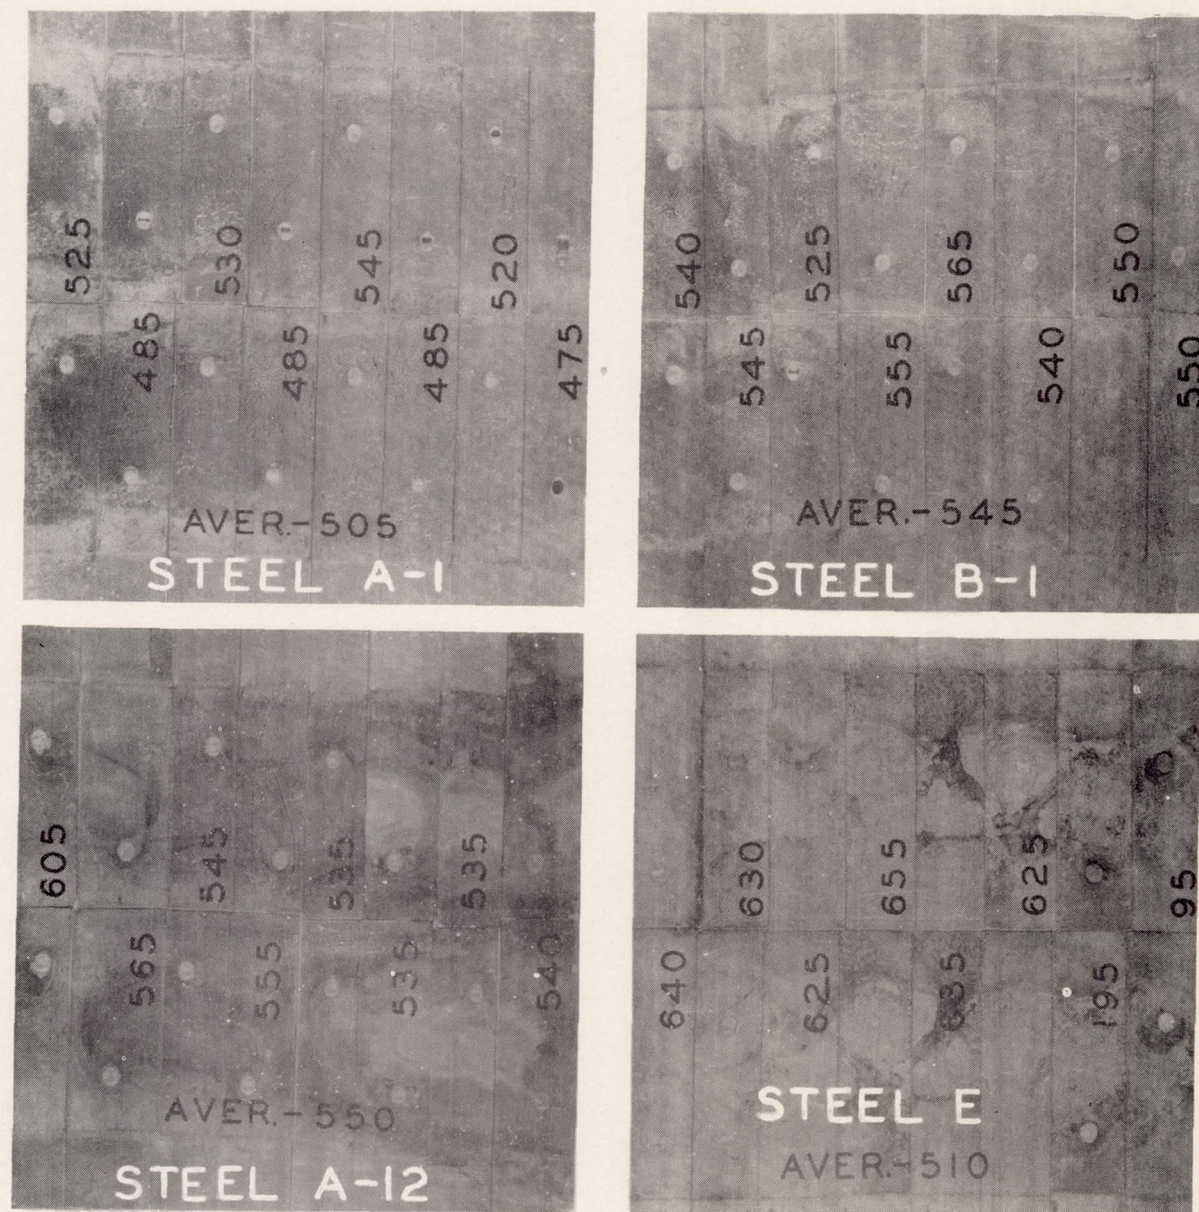
On all the 18:8 type steels to which petrolatum grease was applied at the faying surfaces prior to shot welding, little or no corrosion was noted at the overlaps after 3 years of exposure to tidewater or the weather at Hampton Roads (figs. 25 and 26), and most of the grease was still in situ. When such greasing was omitted, however, from 50 to 80 percent of these areas were covered with rust. On steel E some rusting occurred at the faying surfaces, even though grease had been applied.

Figure 25.- The faying surfaces of representative shot-welded panels exposed to tidewater at Hampton Roads, Va. for three years shown after tensile tests were made. The breaking load for each weld is indicated on the photograph. Note the lack of rust on samples having a grease at the faying surfaces prior to shot-welding (Steels A-1 and B-1). x 3/4

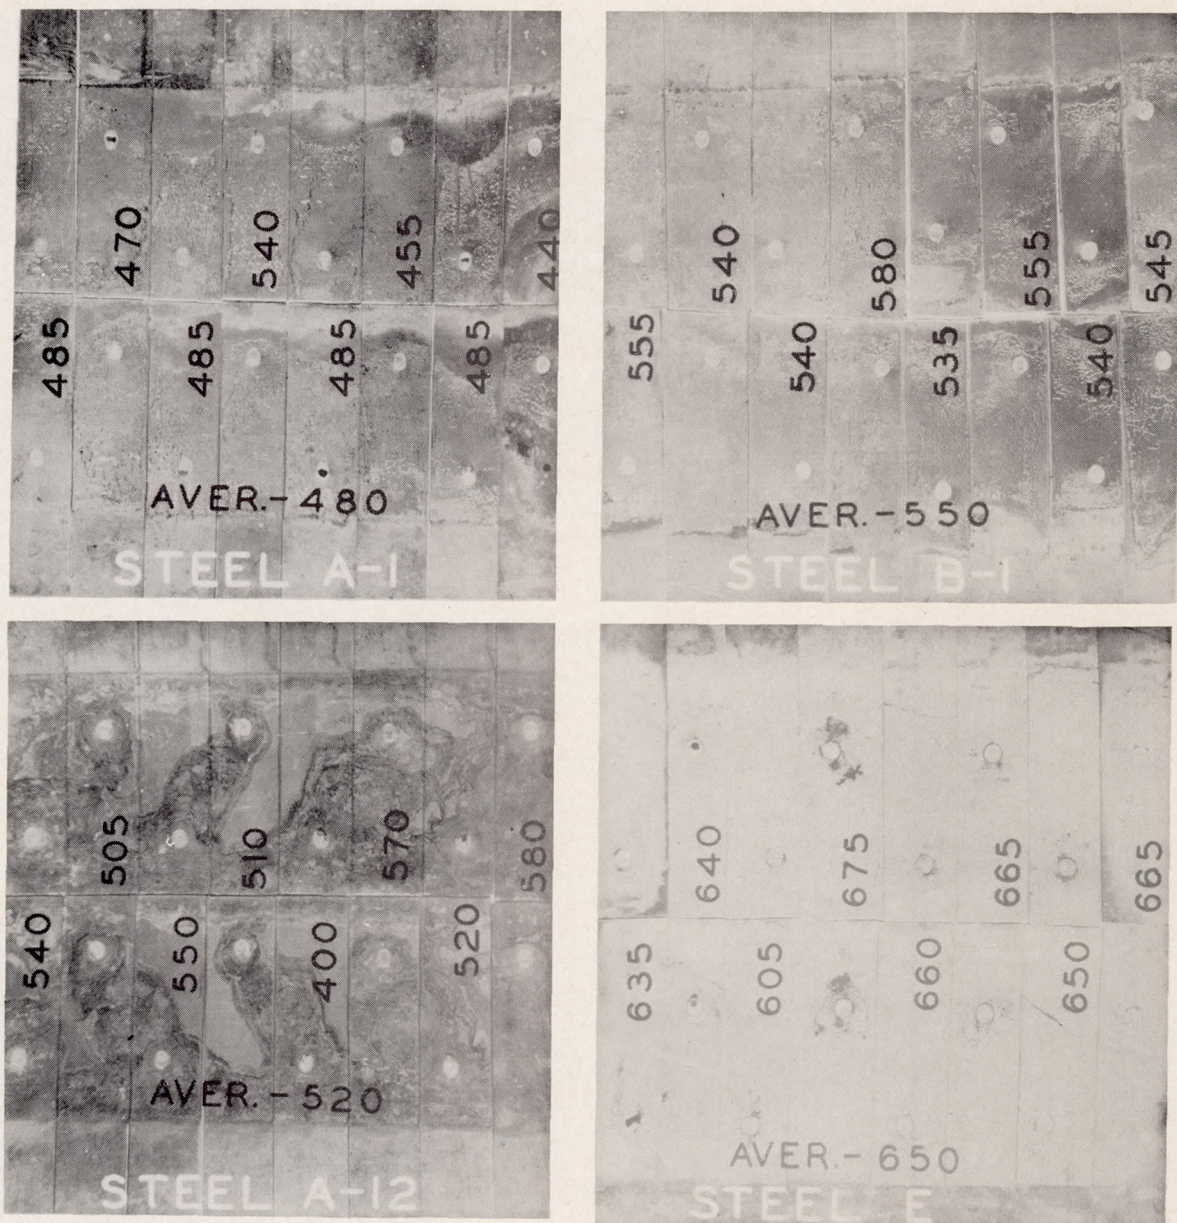
Figure 26.- The faying surfaces of panels, comparable to those shown in figure 25, but exposed to the weather for three years at Hampton Roads, Va. Surfaces to which no grease was applied prior to welding (Steel A-12) exhibit considerable rust. x 3/4.

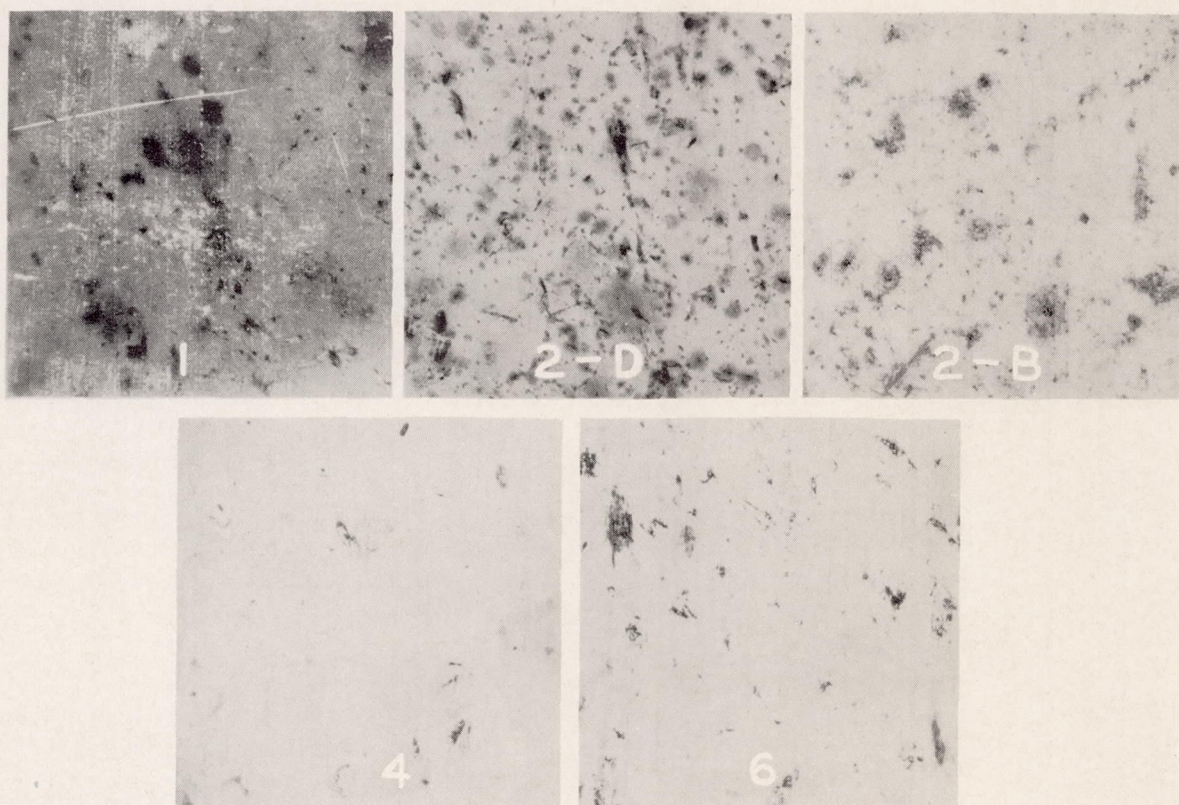
The rust tended to form on isolated areas, approximately 1/2 inch in diameter, on panels having the No. 1 and No. 2-D finishes. The deposits were thicker on the No. 1 than on the No. 2-D finish, and were noticeably heavier on these two finishes than on the others. Although the rust on the surfaces having Nos. 2-B, No. 4, and No. 6 finishes was, in general, much more superficial, the number of individual areas of rust were more numerous and of smaller size, seldom exceeding 1/8 inch in diameter. The amount of rust on the No. 2-B and No. 4 finishes was approximately the same, but in general tended to be somewhat less on the No. 6 finish. A No. 7 finish, the highest degree of polish of the panels tested and applied only to the straight 18:8 steels, exhibited the least rust.

Figure 27.- Earthward surfaces of panels with different commercial surface finishes, after exposure to the weather at Hampton Roads, Va. for six months. Note the decrease in quantity and thickness of the corrosion products, as the degree of surface finish is improved. xl.

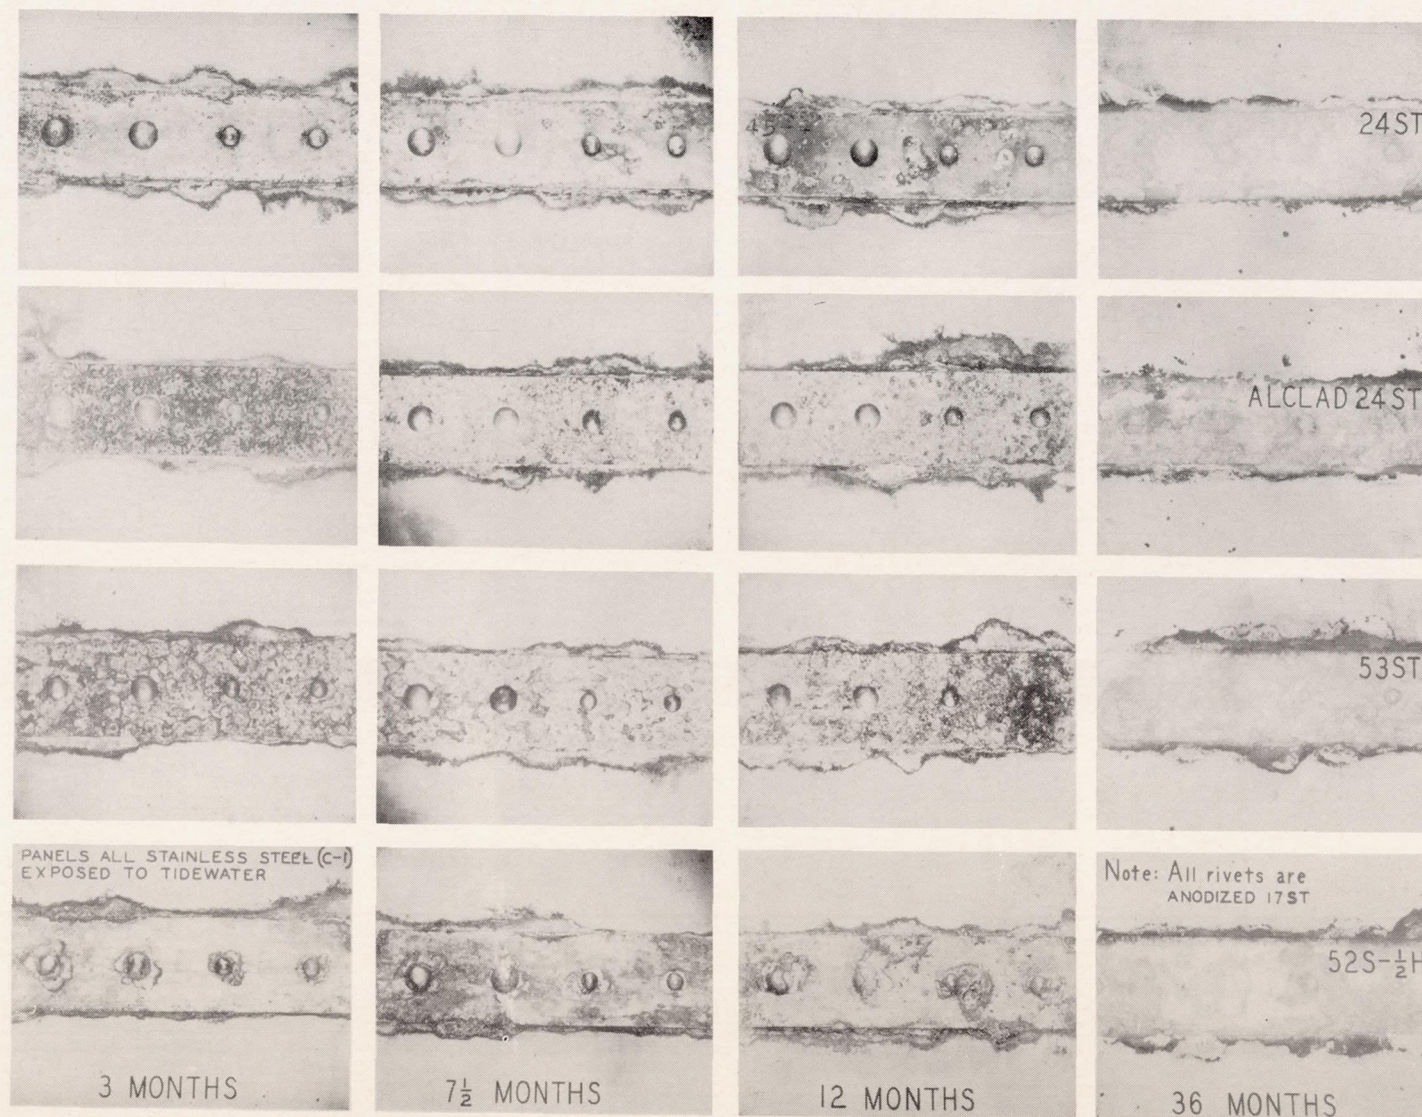
Both the macroscopic and microscopic examinations revealed that alloys 24S-T and Alclad 24S-T were the most severely attacked, with 53S-T somewhat less so, and 52S-1/2H the least. This does not necessarily indicate the order of the potential differences involved since the 52S-1/2H and Alclad 24S-T alloys are inherently the most resistant to corrosion.

Figure 28.- Strips of aluminum alloys, coupled in a 1:7 area ratio on panels of stainless steel, and exposed to the tidewater at Hampton Roads, Va. for the periods indicated. Note the severe corrosion on the strips and the quantities of corrosion products accumulated at the edges of juncture. x 1/2.

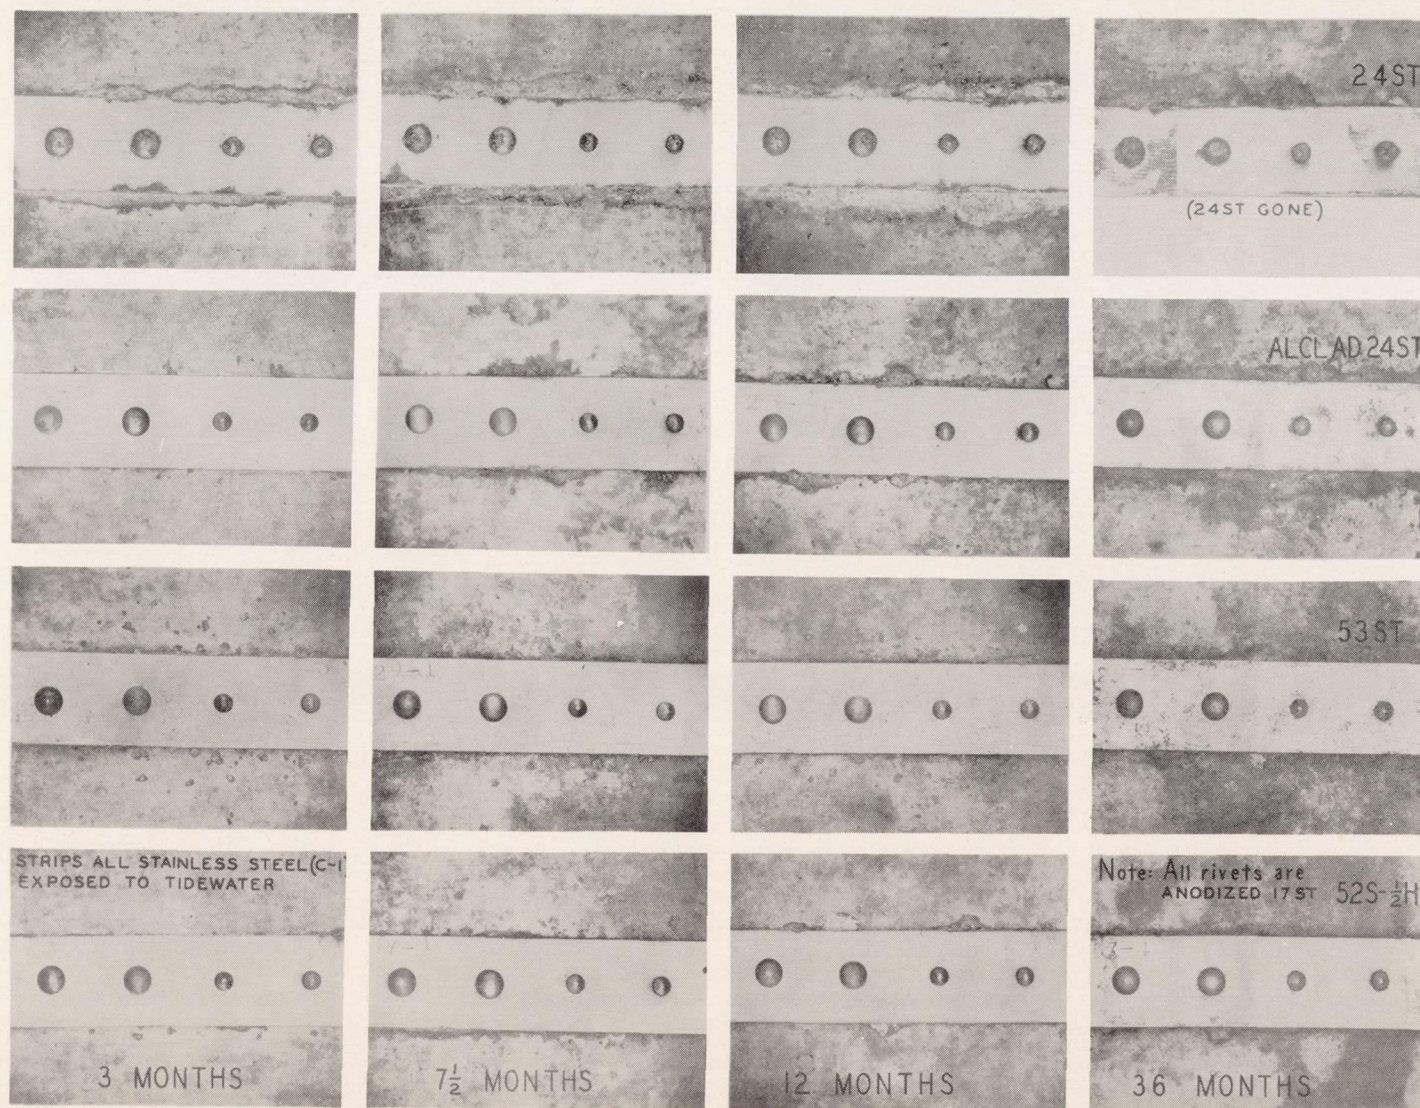
Figure 29.- Strips of stainless steel, coupled in a 1:7 area ratio with panels of aluminum alloys, and exposed to the tidewater at Hampton Roads, Va. for the periods indicated. Note that the aluminum alloys are less severely attacked, and the quantities of corrosion products at the edges of juncture are less than in figure 28. x 1/2.

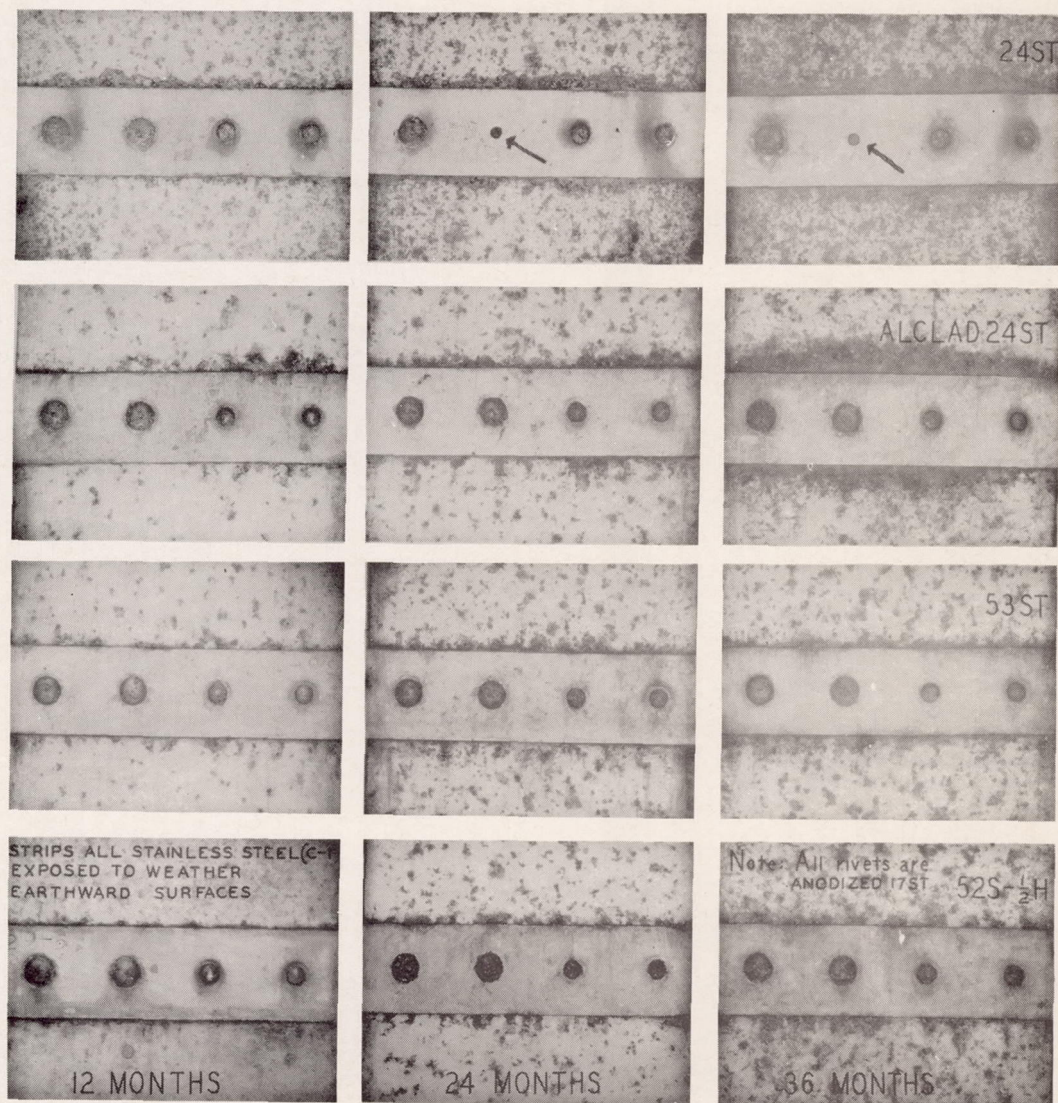
Identical couples exposed to the weather (fig. 30) corroded similarly to those in tidewater but at a much slower rate. In some instances (fig. 30, alloy 24S-T) the accumulation of corrosion products at the faying surface resulted in sufficient stress to break off rivet heads. Stress-corrosion cracks, for the same reason, were present on some of the 24S T exposed to the weather or tidewater, and on the Alclad, 24S-T strips exposed to tidewater (fig. 31C) attached to stainless steel panels.

Figure 30.- Earthward surfaces of strips of stainless steel coupled in a 1:7 area ratio with panels of aluminum alloys, and exposed to the weather at Hampton Roads, Va. for the periods indicated. Note that two rivet heads, joining the steel to alloy 24ST (arrows), have broken off because of the stresses imposed by the corrosion products at the faying surfaces. x 1/2.

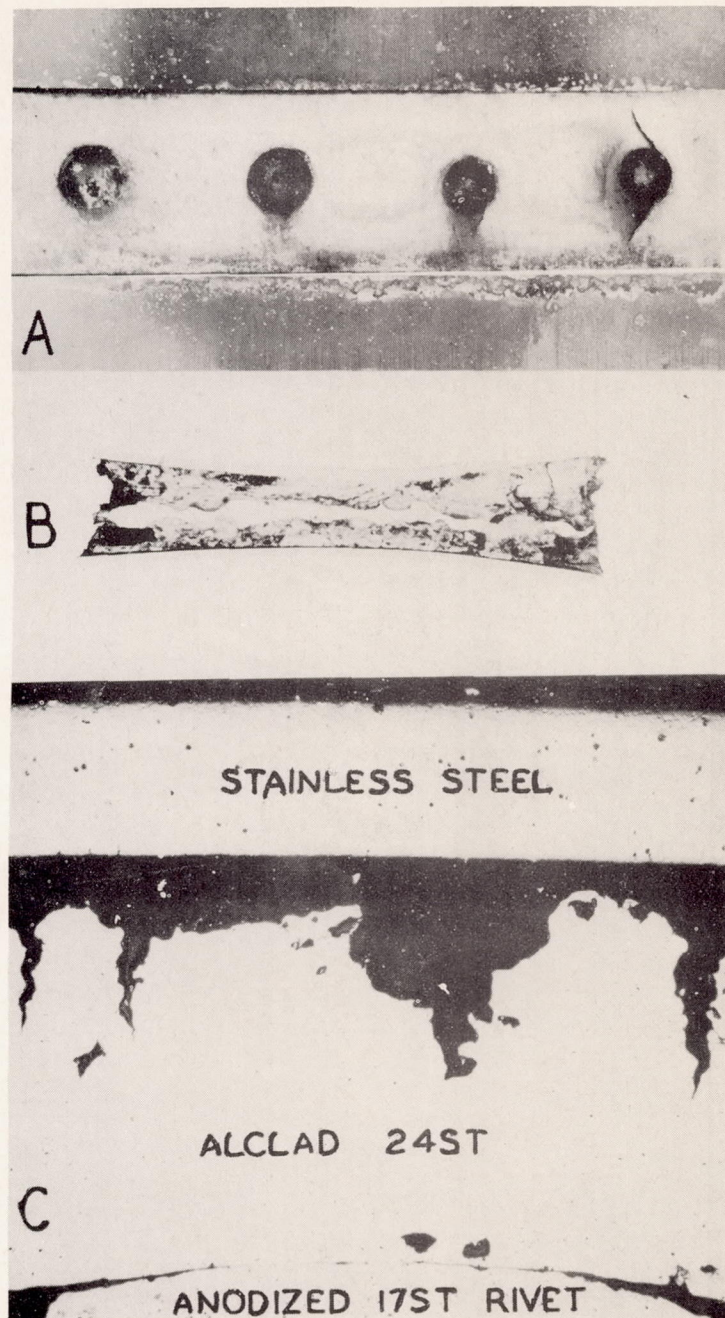
Figure 31.- Examples of stress corrosion on panels having stainless steel coupled with light metal alloys. A, Crack on stainless steel strip joined to a magnesium alloy panel, Dowmetal M. Exposed two years to the weather, earthward surface. x 1. B, Cross-section showing the large amount of corrosion products at the faying surfaces of (A). x 2-1/2. C, Cracks in Alclad 24ST strip attached to a stainless steel panel, exposed to tidewater for two years. x 50.

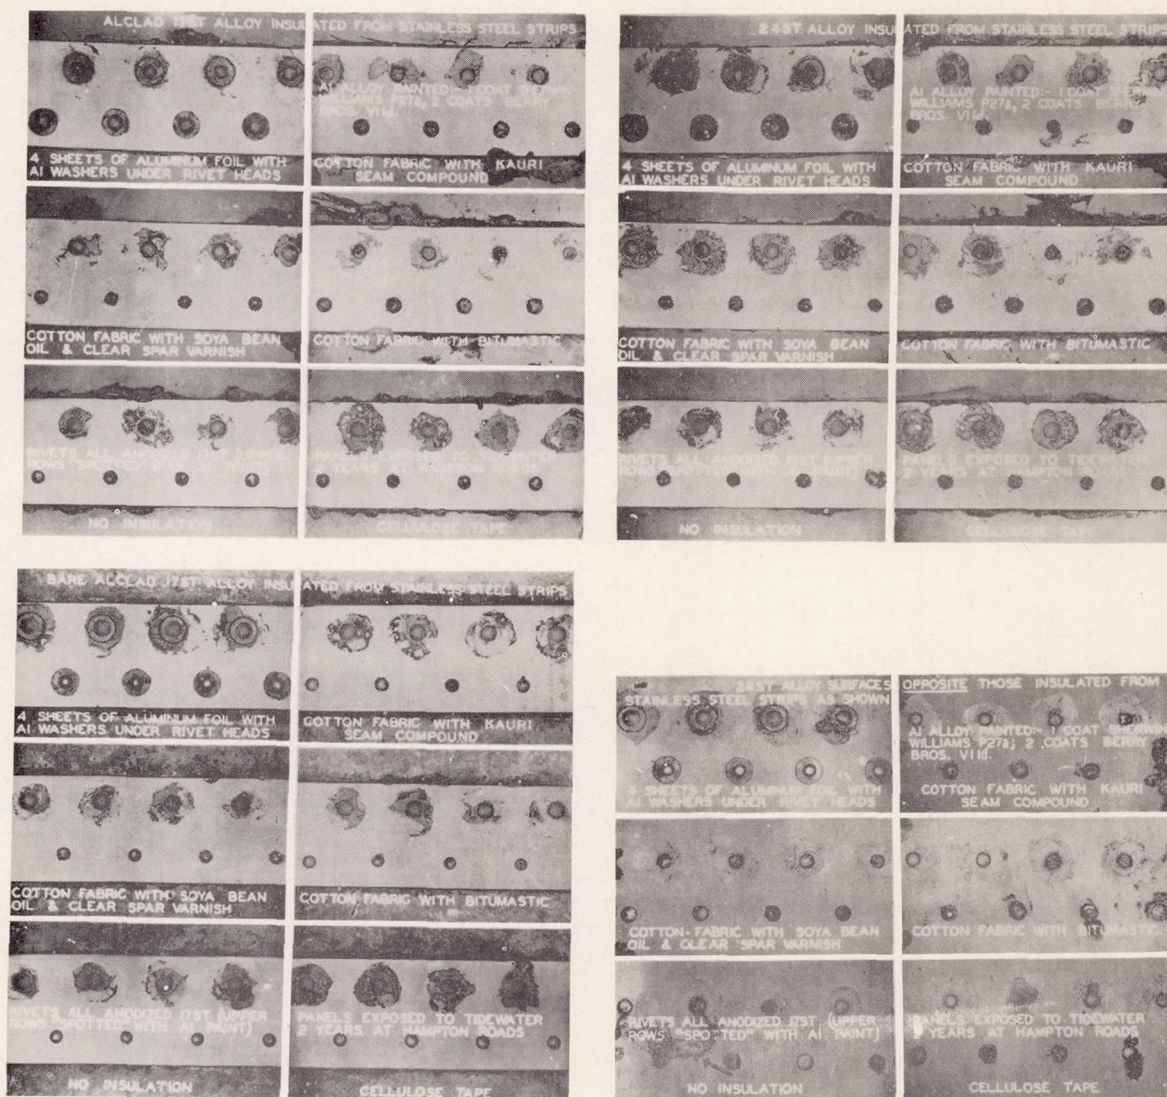
Figure 32.- Panels of aluminum alloys joined to stainless steel strips and exposed to tidewater at Hampton Roads, Va. for two years with the various insulators between the strips and the panels. The upper rows of rivet heads were painted with an aluminum pigmented varnish. Note the absence of corrosion products along the edges of the strips insulated by aluminum foil. x 2/5.

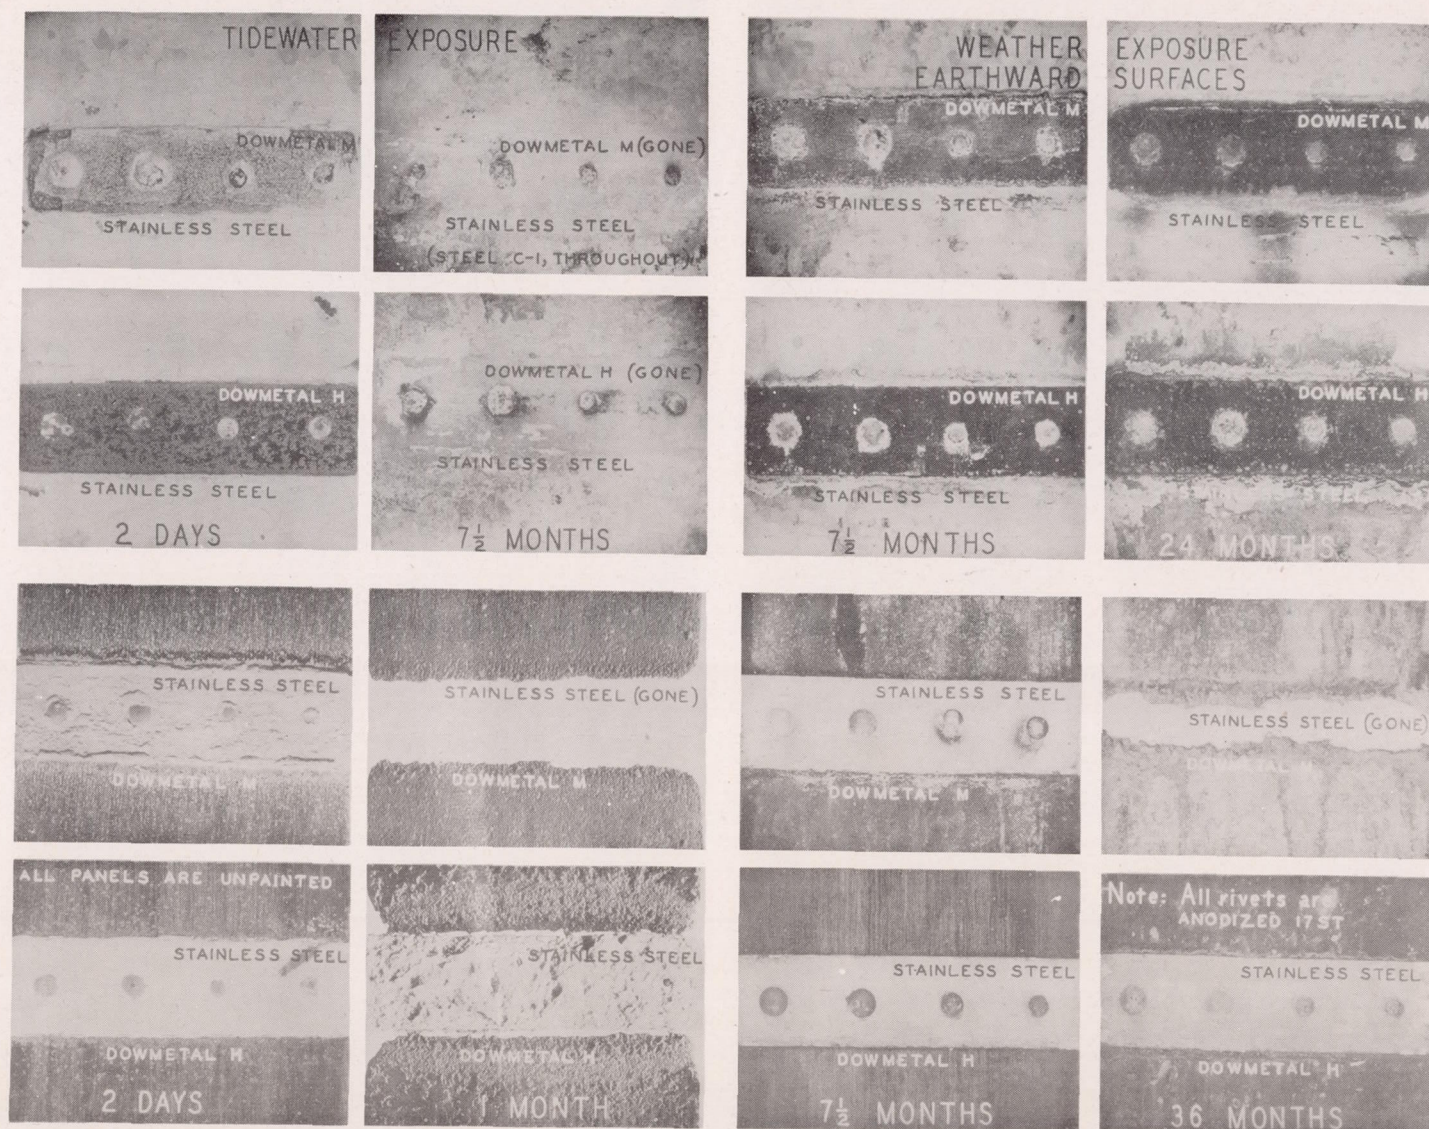
Two unpainted magnesium alloys, Dowmetals M and H, were very severely attacked when coupled with stainless steel, especially when exposed to tidewater at Hampton Roads. Immediately after the first tidewater had covered these panels, violent bubbling of the water occurred, and the reaction was audible at a distance of approximately 15 feet. An adherent white corrosion product was deposited on the steel, which attained a thickness of 0.004 inch on the second day of exposure (fig. 33), at which time the first set of unpainted panels was removed. The white deposit gradually disappeared, and the underlying steel was found unattacked. The Dowmetal M was attacked somewhat more rapidly than the Dowmetal H. The unpainted panels were removed from the tidewater racks after 1/15, 1, 3, and 12 months, while panels painted prior to exposure (fig. 34) were removed from the tidewater racks after 1, 3,  $7\frac{1}{2}$ , and 12 months. The paint schedule consisted of 1 coat of zinc chromate primer and 3 coats of aluminum-pigmented varnish (Navy Specification V10-d).

Figure 33.- Unpainted panels exposed at Hampton Roads, Va., for the periods indicated, having stainless steel and magnesium alloys in contact with each other. Note the electrolytic deposition of white corrosion products on the uncorroded steel, on panels exposed to the tidewater. The upper quadrants show Dowmetal strips on steel; the lower quadrants show the reverse arrangement. x 1/2.

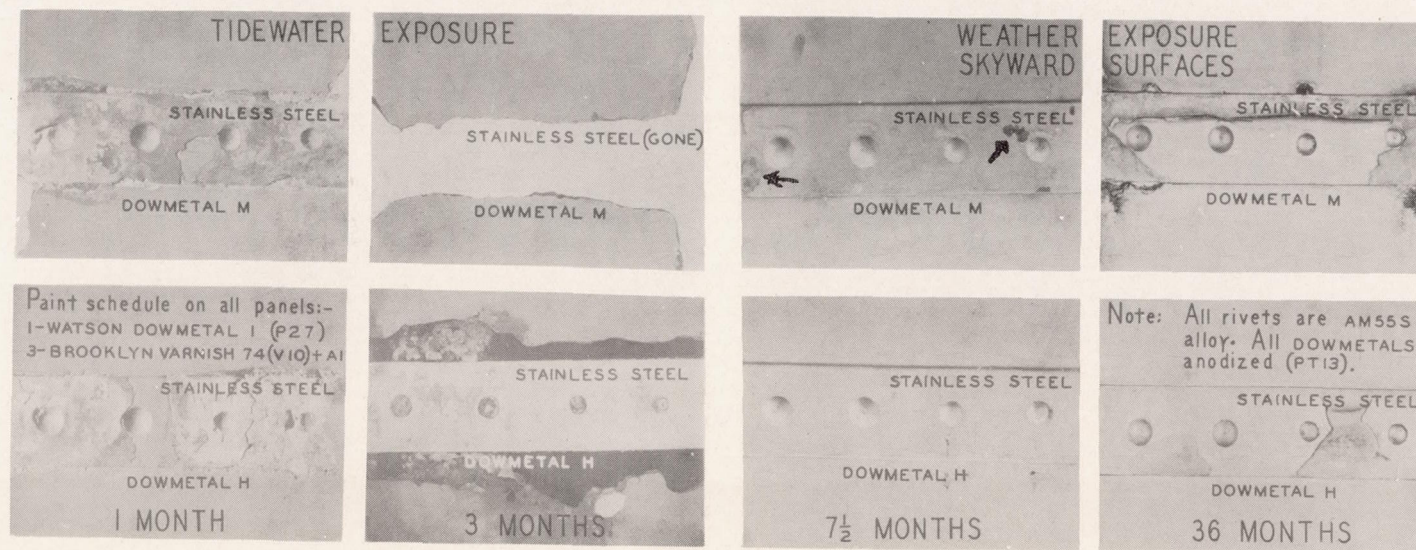
Figure 34.- Painted panels, comparable with those shown in figure 33, after exposure at Hampton Roads, Va. Note that the paint afforded little protection against tidewater exposure, and that it began to fail to adhere to the stainless steel strips after 7-1/2 months of weather-exposure (arrows). x 1/2.
